Imagery Insert Form

The U.S. Environmental Protection Agency is enclosing a copy of the final Preliminary Assessment/Visual Site Inspection (PA/VSI) report for the referenced facility. The executive summary and conclusions and recommendations sections have been withheld as Enforcement Confidential.

POTENTIAL HAZARDOUS WASTE SITE
PRELIMINARY ASSESSMENT
PART 1 SITE INFORMATION AND ASSESSMENT

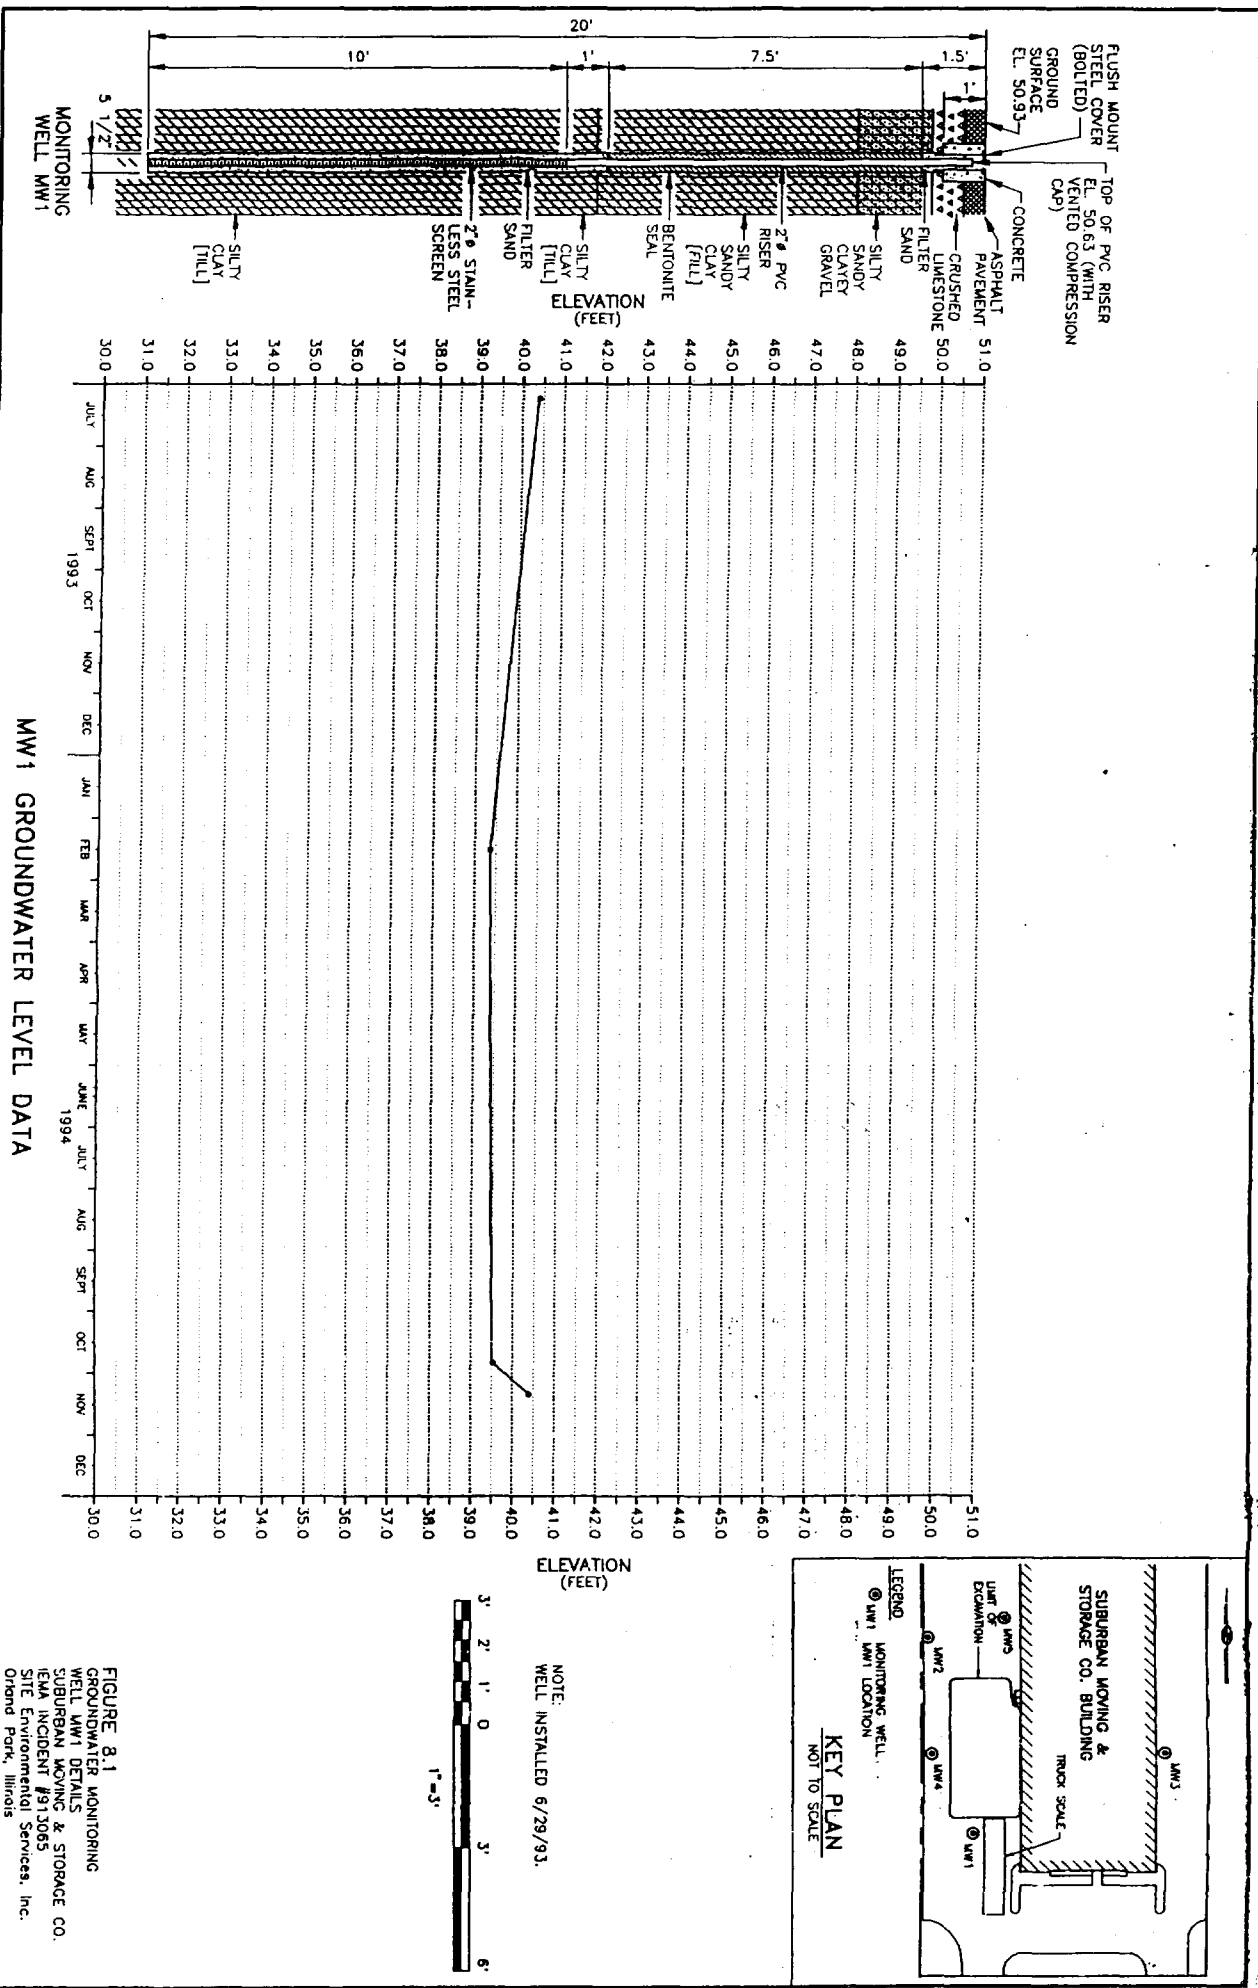
FIGURE 8.1
GROUNDWATER MONITORING
WELL MW1 DETAILS
SUBURBAN MOVING & STORAGE CO.
IEMA INCIDENT #913065
SITE Environmental Services, Inc.
Orland Park, Illinois

Monitoring wells MW4 and MW5 were installed to a depth of 15 feet each, with each consisting of a 10-foot long stainless steel screen and PVC riser. Well construction details are shown in Figures 8.1 through 8.5 in Appendix 1. As indicated on the Figures in Appendix 1 and the boring logs in Appendix 2, groundwater was measured at a depth of about 3.5 feet at upgradient monitoring well MW3, and between about 7 and 10.5 feet at monitoring wells MW1, 2, and 5. Groundwater accumulation in MW4 was very slow, and the water level had risen to a depth of 14 feet after 18 days. Groundwater flow was determined to be west of northwest.

MW1 GROUNDWATER LEVEL DATA

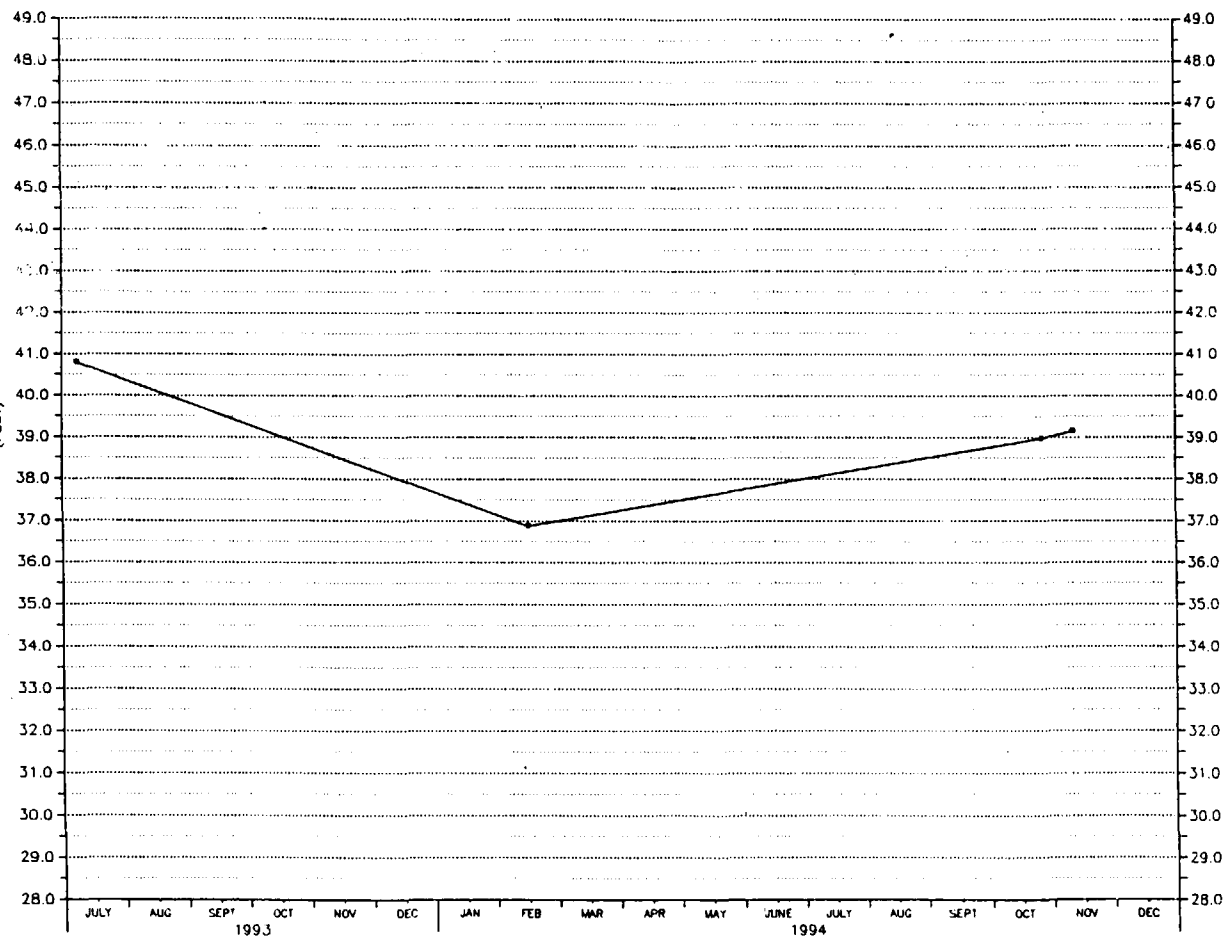
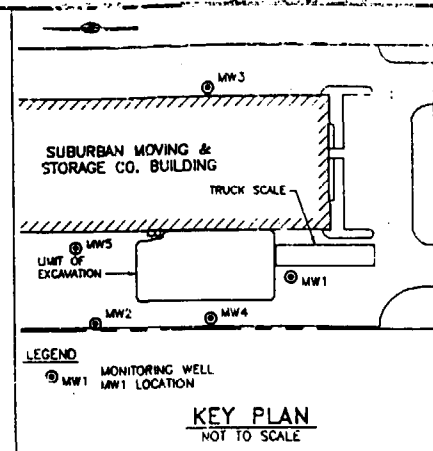
FIGURE B.2
 GROUNDWATER MONITORING
 WELL MW2 DETAILS
 SUBURBAN MOVING & STORAGE CO.
 IEMA INCIDENT #913065
 SITE Environmental Services, Inc.
 Orland Park, Illinois

MW2 GROUNDWATER LEVEL DATA

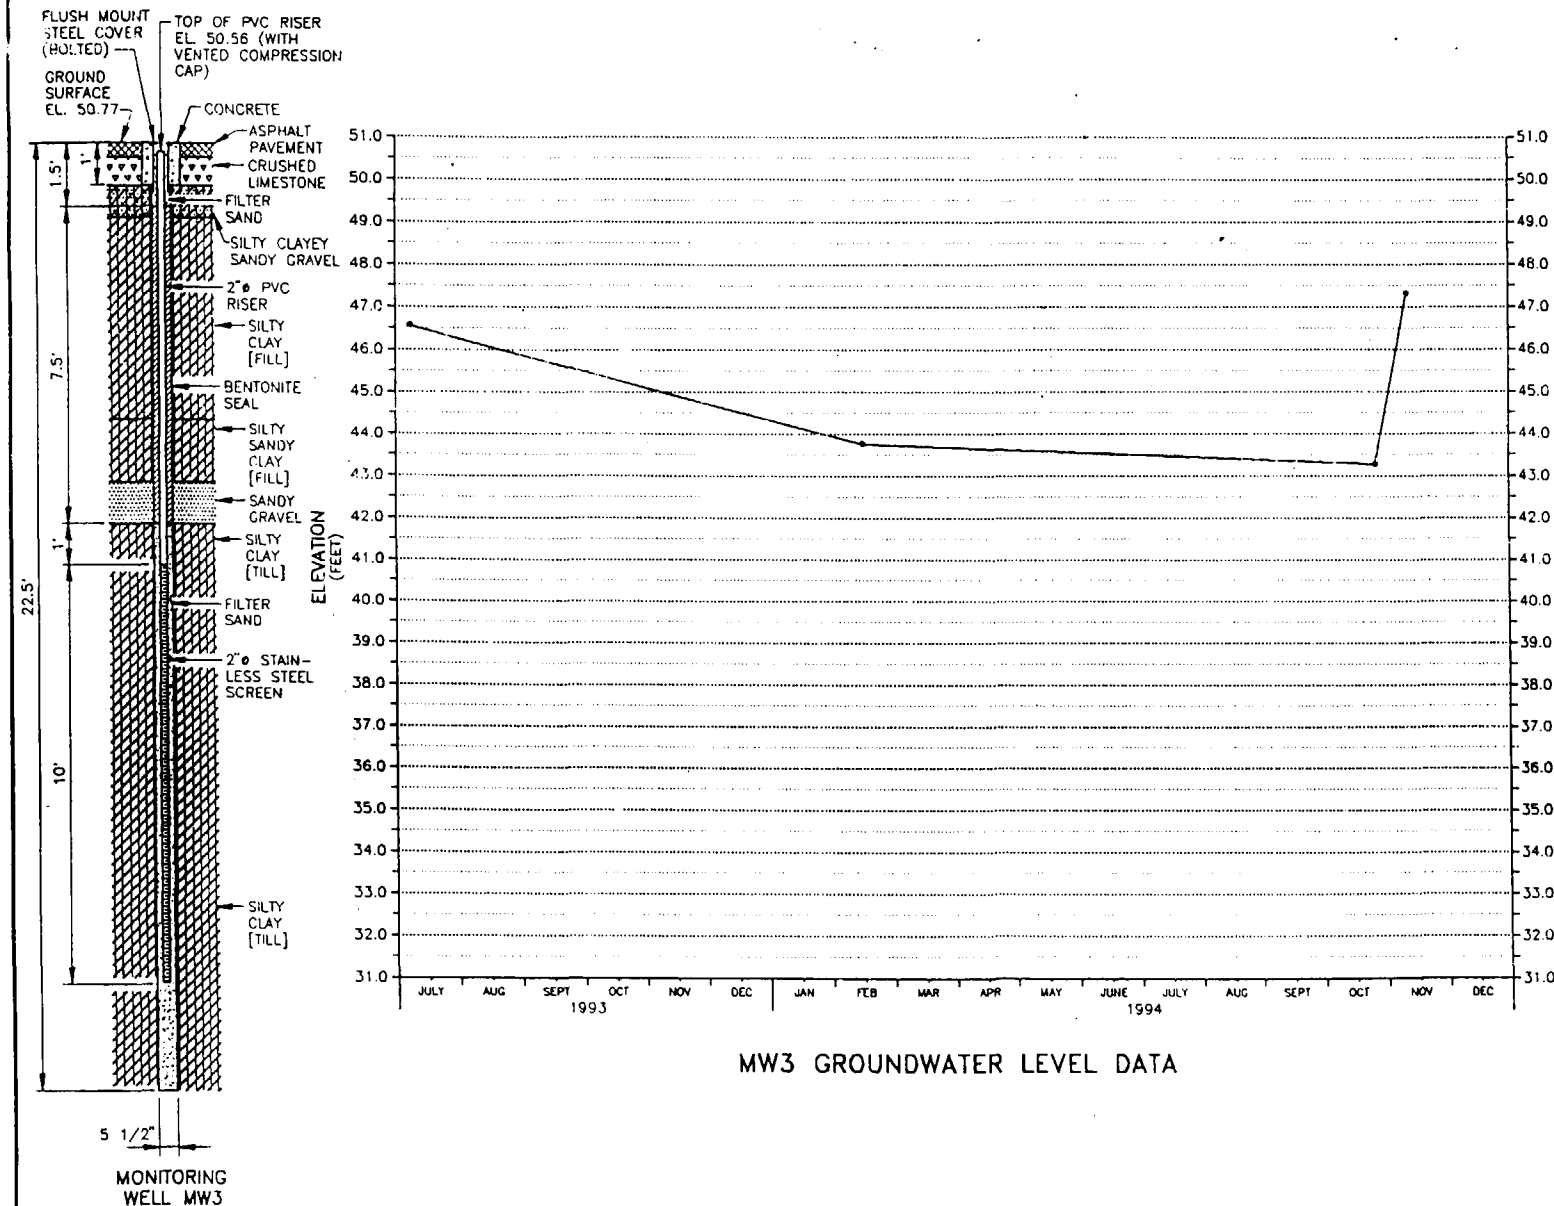
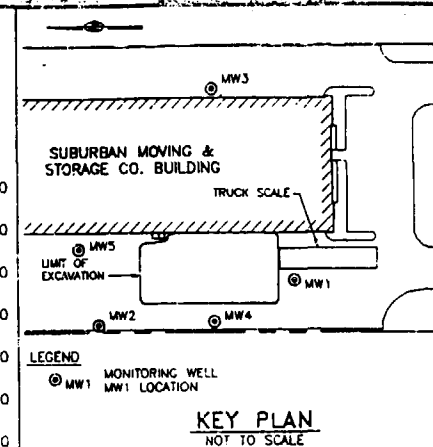
FIGURE 8.3
GROUNDWATER MONITORING
WELL MW3 DETAILS
SUBURBAN MOVING & STORAGE CO.
EMA INCIDENT #913065
SITE Environmental Services, Inc.
Orland Park, Illinois

NOTE:
WELL INSTALLED 6/29/93.

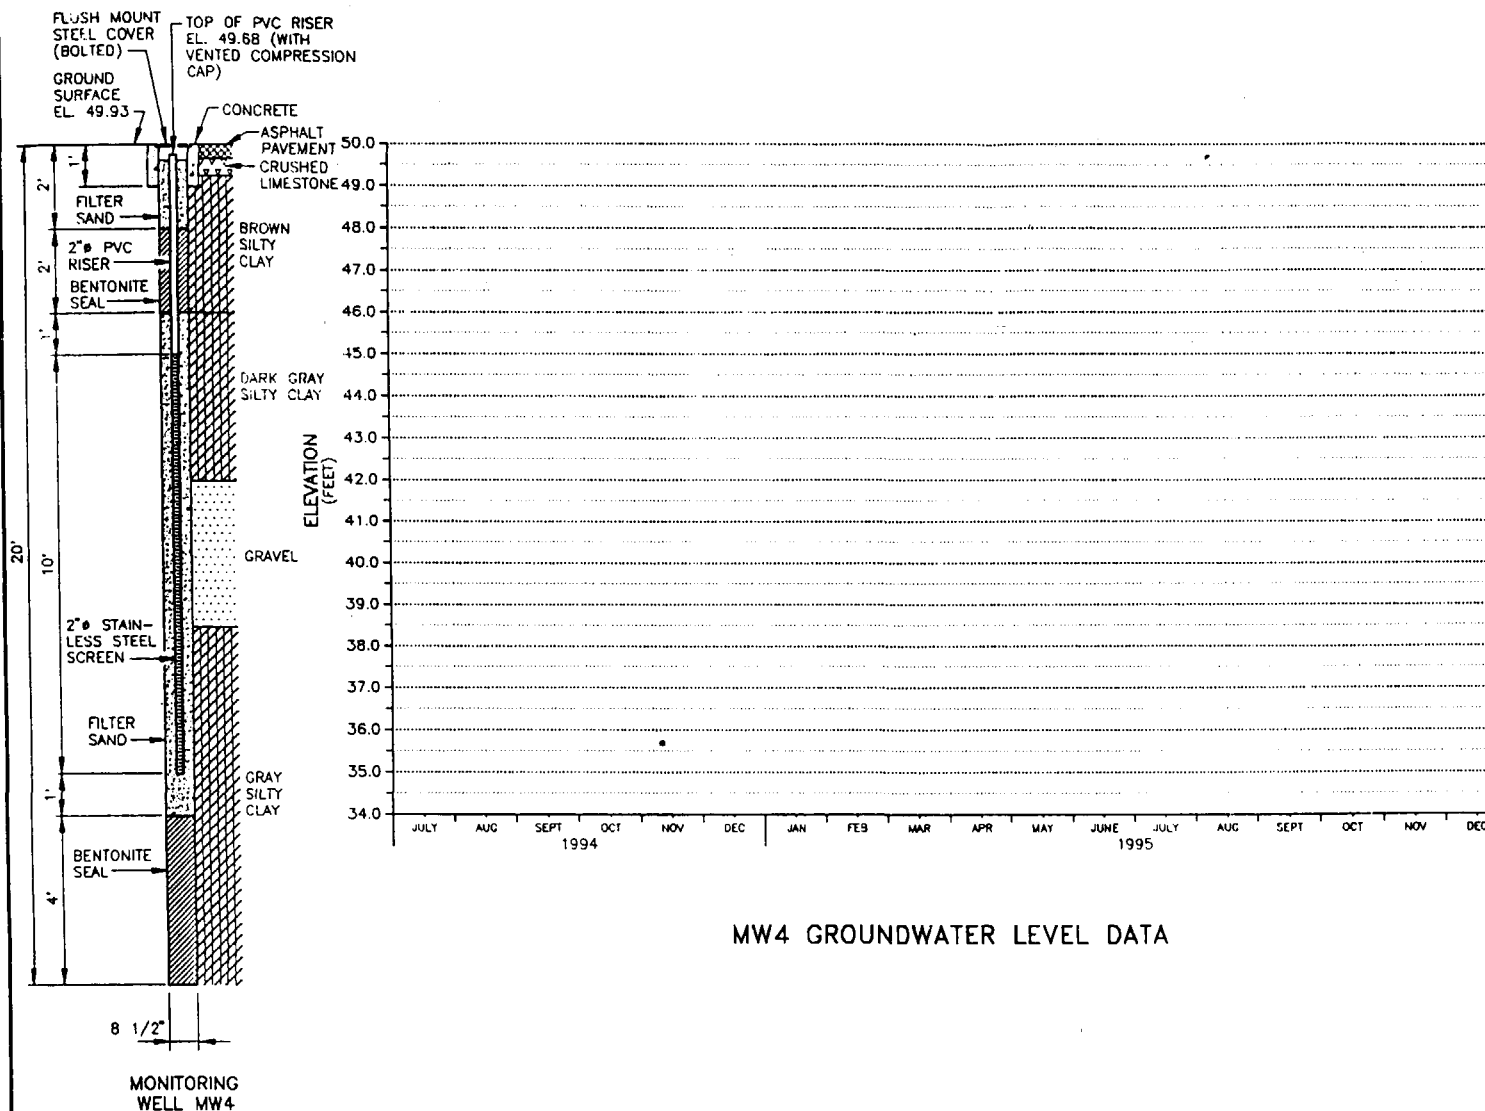
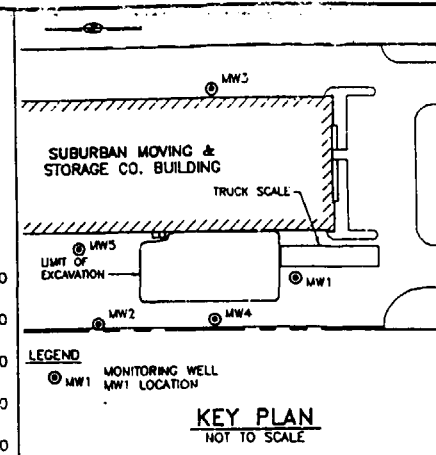
FIGURE 8.4
GROUNDWATER MONITORING
WELL MW4 DETAILS
SUBURBAN MOVING & STORAGE CO.
IEMA INCIDENT #913065
SITE Environmental Services, Inc.
Orland Park, Illinois

MW4 GROUNDWATER LEVEL DATA

TOP OF PVC RISER
47.86 (WITH
UNTESTED COMPRESSION
SP)

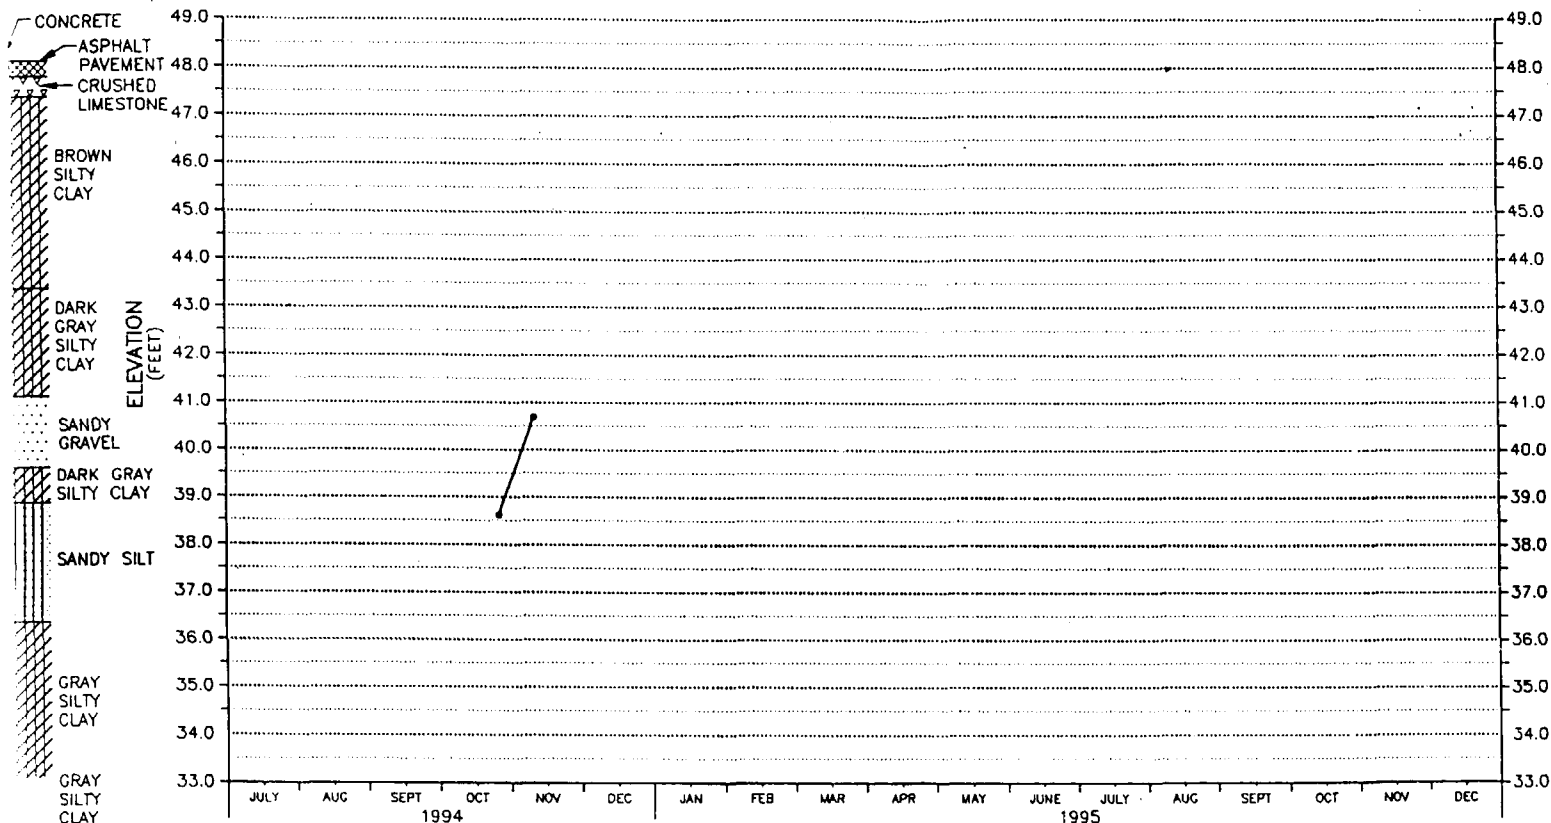
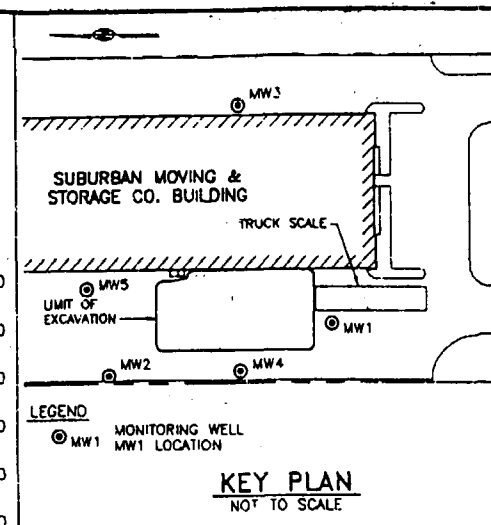
FIGURE 8.5
GROUNDWATER MONITORING
WELL MW5 DETAILS
SUBURBAN MOVING & STORAGE CO.
IEMA INCIDENT #913065
SITE Environmental Services, Inc.
Orland Park, Illinois

MW5 GROUNDWATER LEVEL DATA

NOTE:
WELL INSTALLED 10/24/94.
